PROJECT ADMINISTRATION DATA SHEET

Cost Sharing Amount: \$ 67,271 Cost Sharing No: D-48-325Title: National Historic Landmark Program

NATIONAL HISTORIC LANDMARKS
BUILDING CONDITION ASSESSMENT PROGRAM
NATIONAL PARK SERVICE
FIELD OPERATIONS MANUAL - VOLUME I

NATIONAL HISTORIC LANDMARKS
BUILDING CONDITION ASSESSMENT PROGRAM
NATIONAL PARK SERVICE
FIELD OPERATIONS MANUAL - VOLUME II

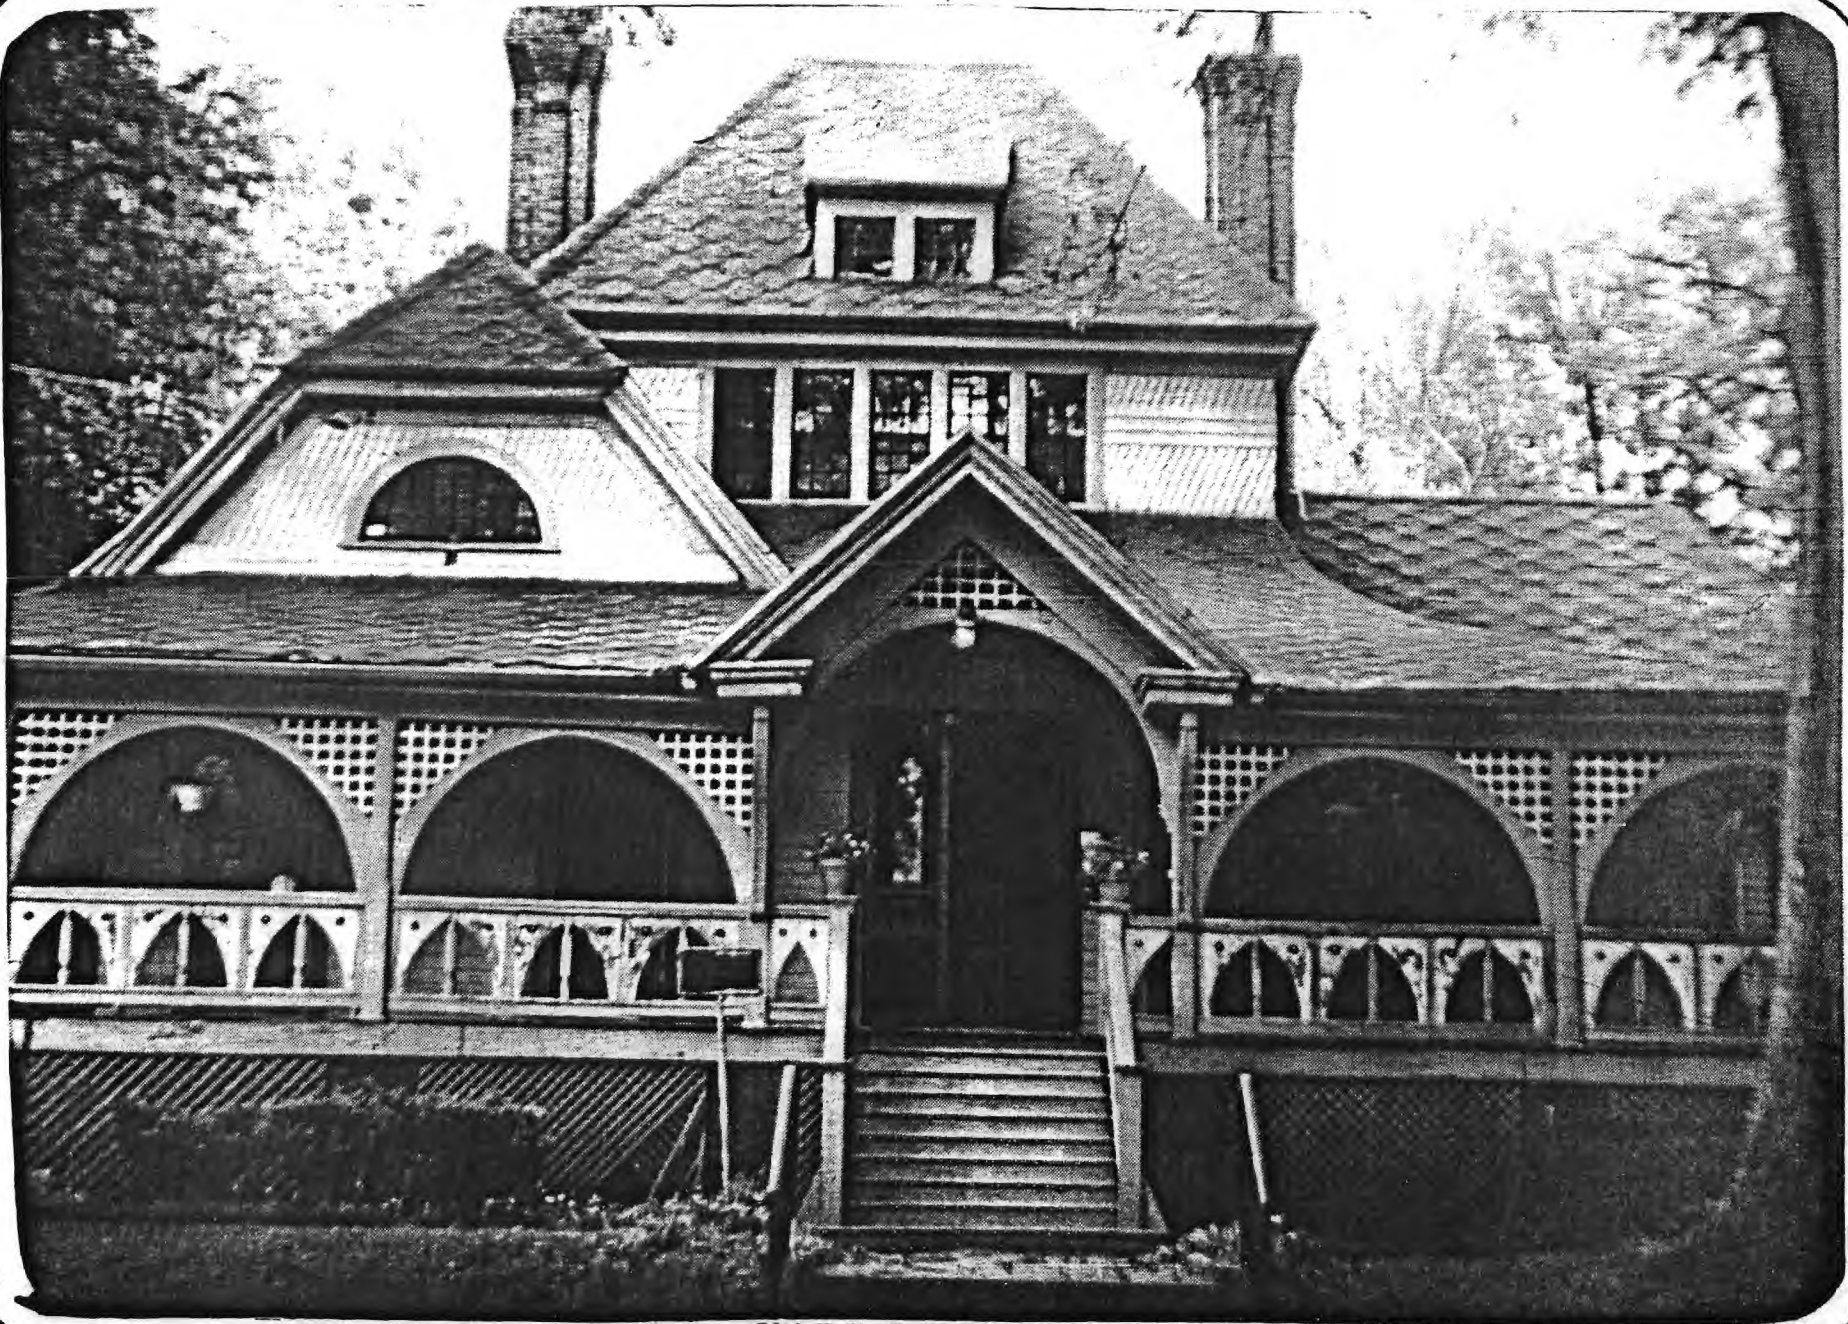
NORTH ELEVATION
Figure 2

NPS will then select those shots that will be reproduced as color xeroxes to be included in the building report. (See Figure 2.)
